HOTHAM HALL
HERITAGE STATEMENT
ISSUE 01 - AUGUST 2021

HOTHAM HALL: HERITAGE STATEMENT

This Heritage Statement has been prepared to inform understanding and significance of Hotham Hall and the potential impact of the current proposals on the historic assets affected. This report has been written to support listed building application 21/03036/PLB submitted to East Riding of Yorkshire Council for Planning Permission and Listed Building Consent for additional works including underfloor heating, and the removal of redundant services attached to the exterior.

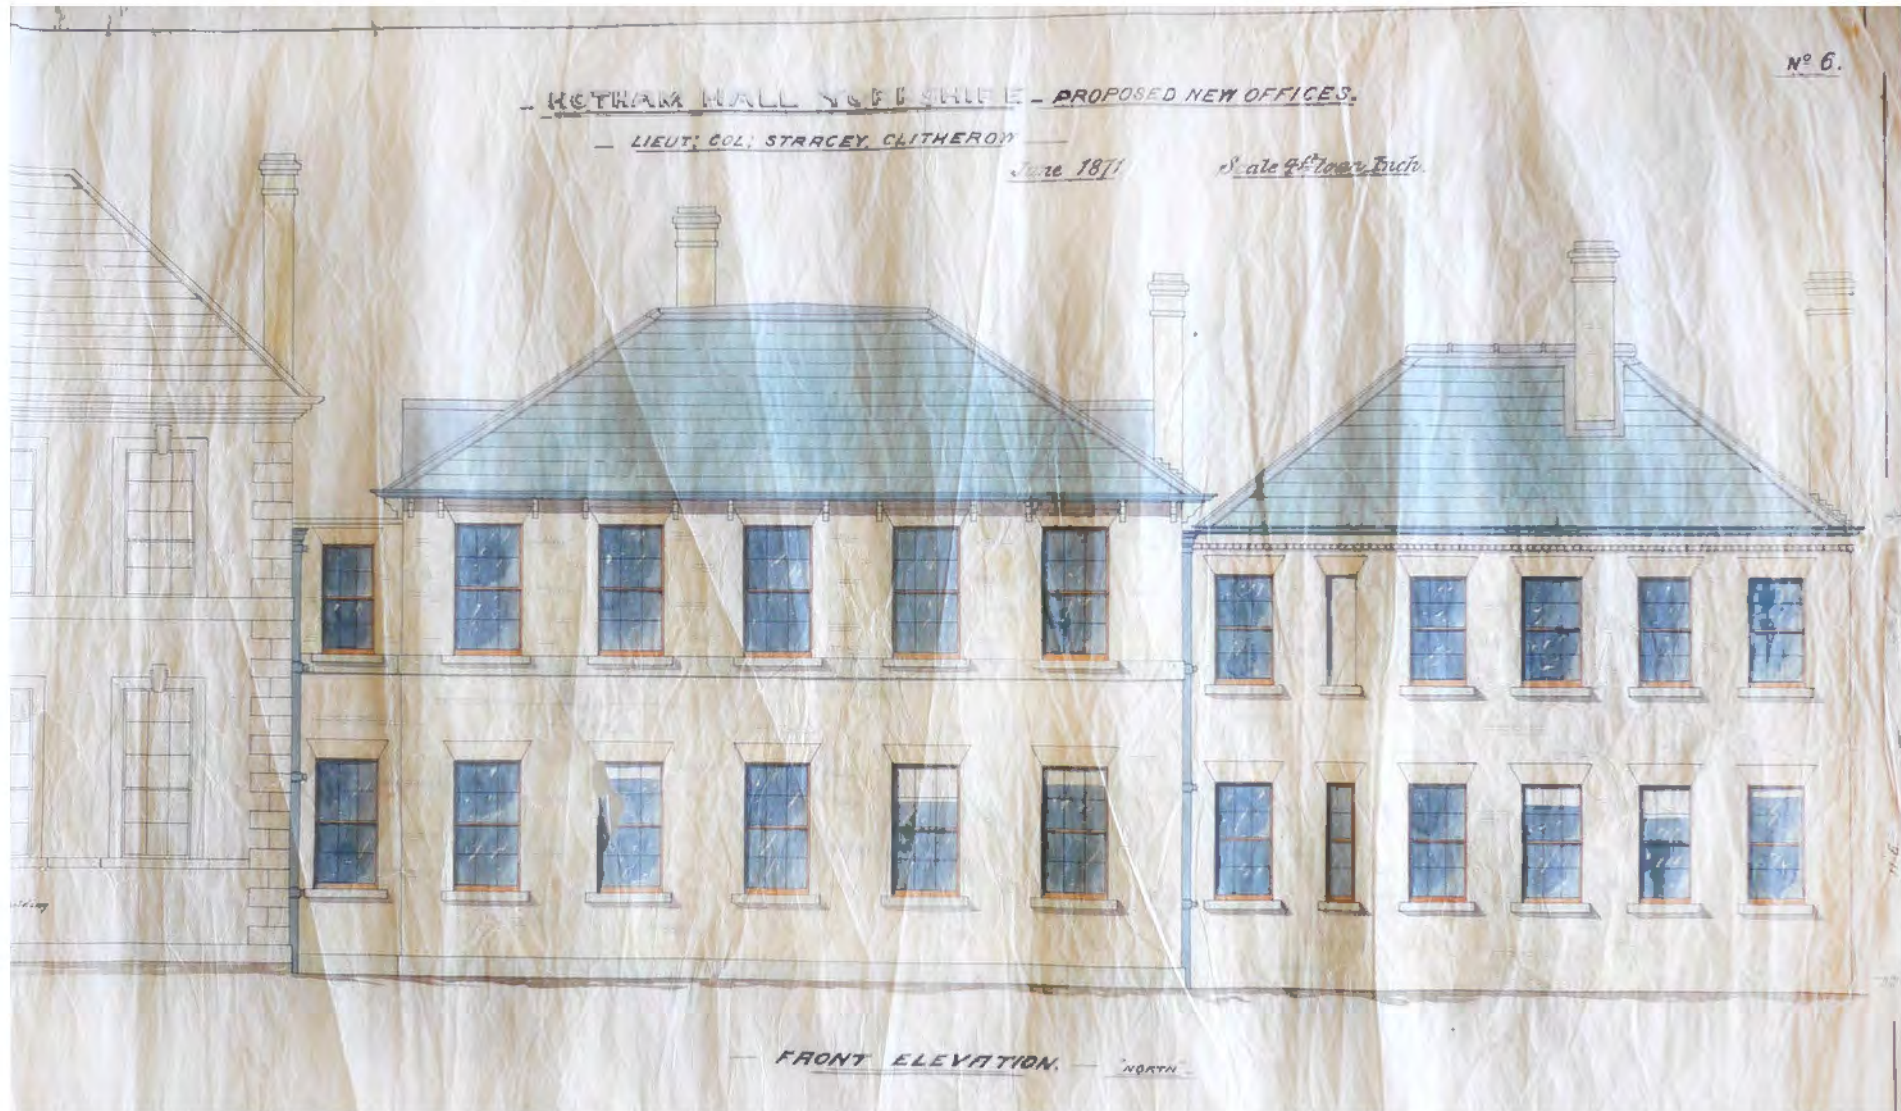
Elevation of the proposed new western extension

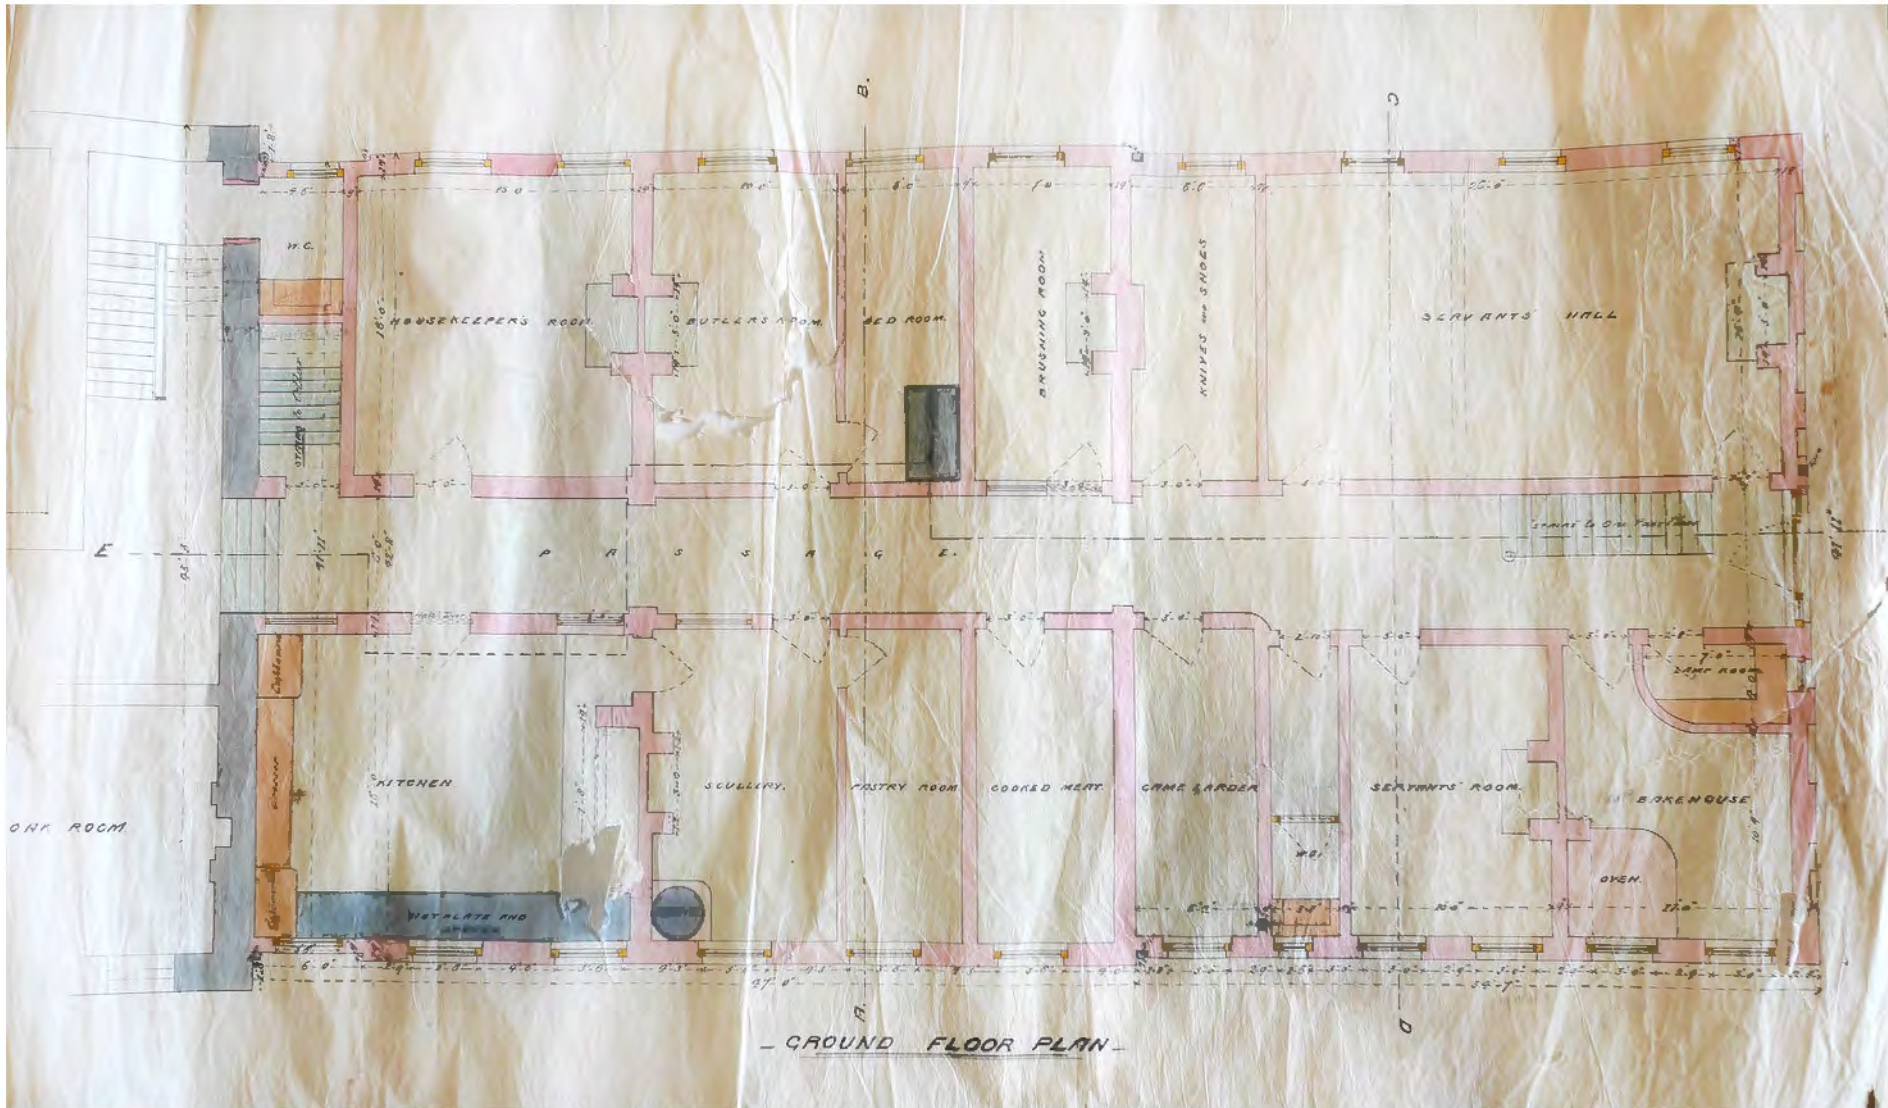
Ground floor plan of the proposed new extension

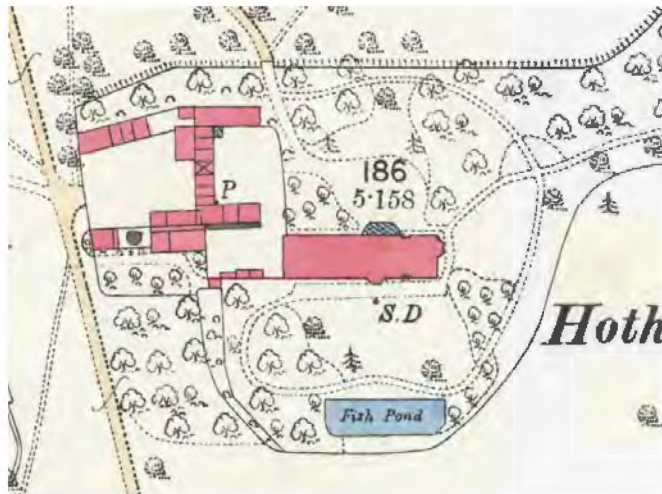
1890 (surveyed 1888) Ordnance Survey 25 inch of Hotham Hall. This shows the new western extension, conservatory to the north elevation and bow-bay window added to the south elevation.

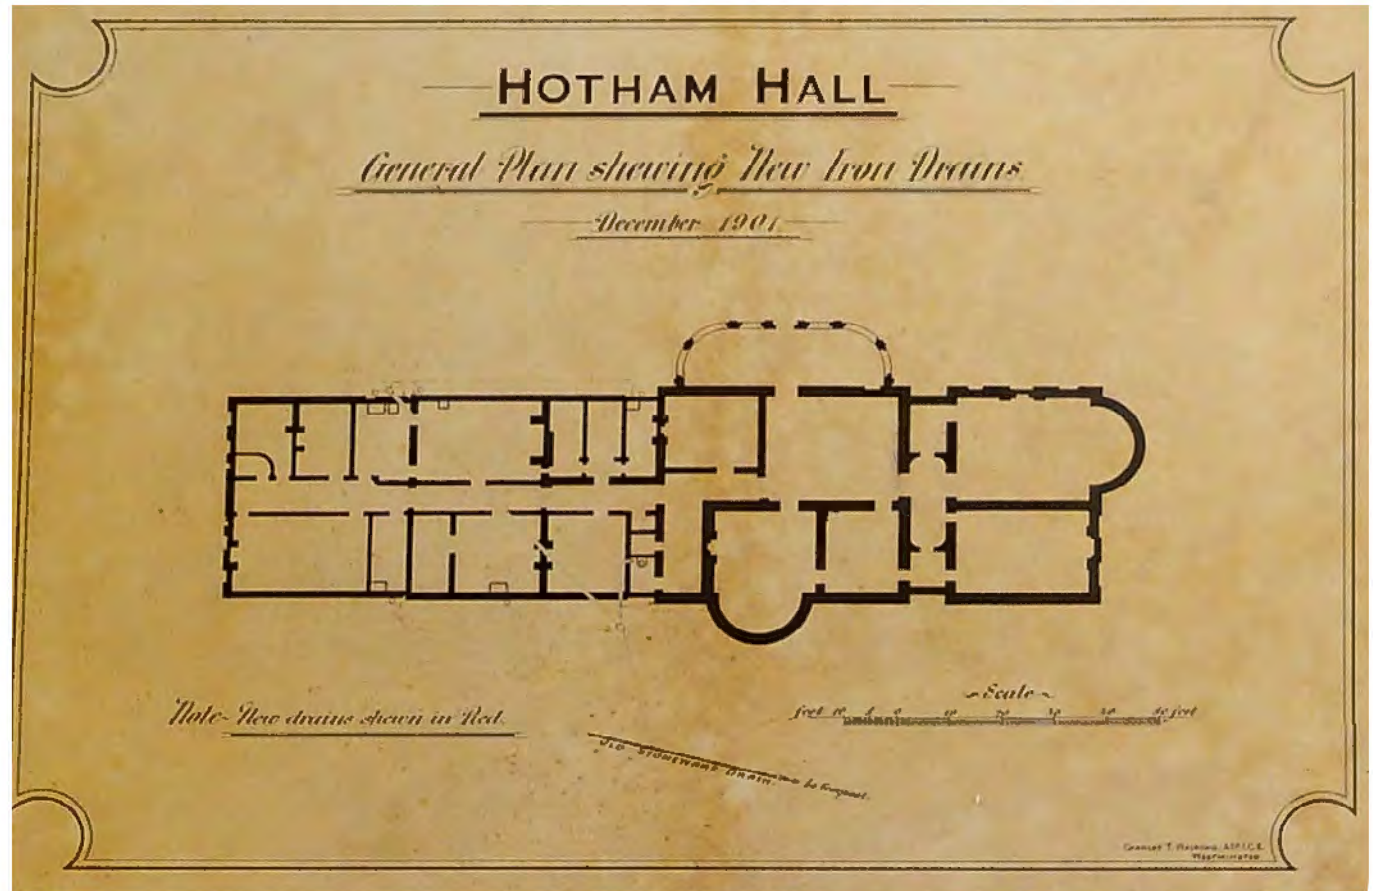
1901 Proposed new drains at Hotham Hall

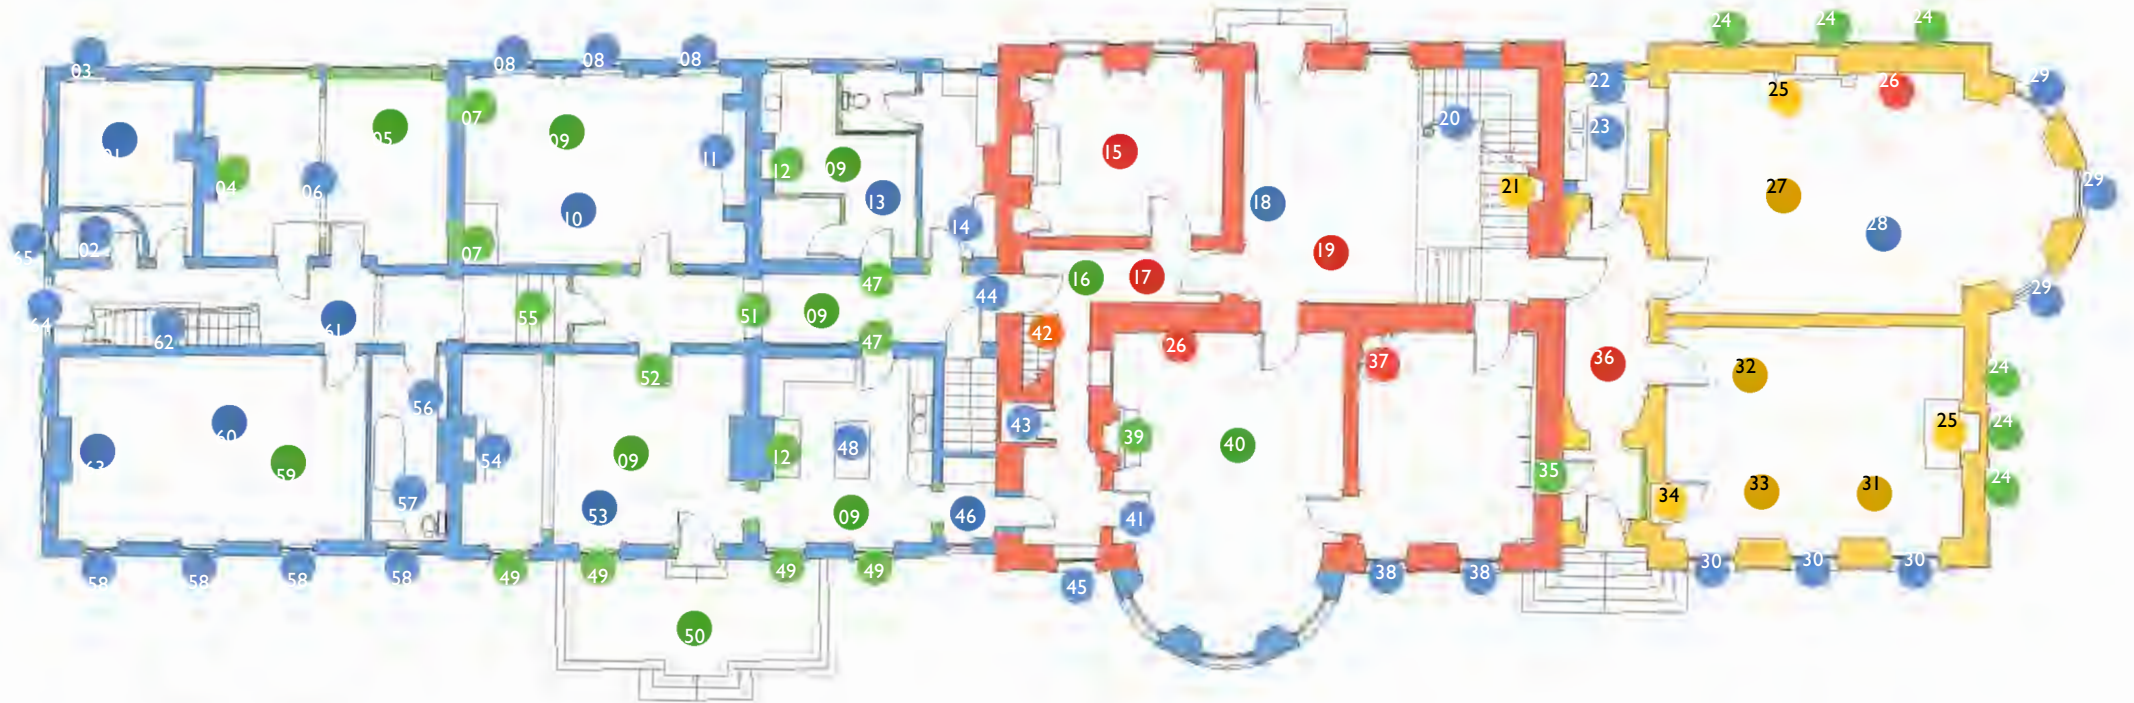
GROUND FLOOR

- 24 Windows replaced late C20
- 25 Fireplace late C18
- 26 Panelling early C18
- 27 Ceiling late C18
- 28 Floor largely replace circa C19
- 29 Windows later C19

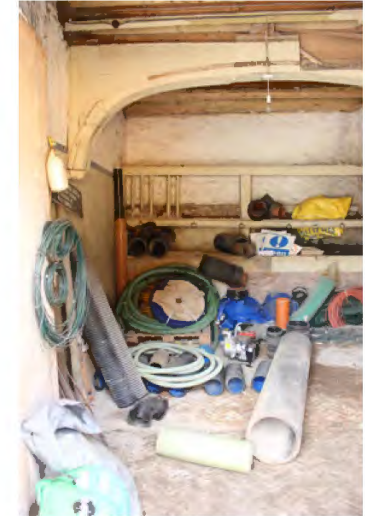
Stable/loose box with brick floor decorative arch and feeding rack

The ground floor also includes a loose box, carriage house, and tack room. The loose box features plaster walls, a decorative timber arch (which concealing a beam), feeding trough, hay rack with tethering rings and herringbone pattern brick floor.

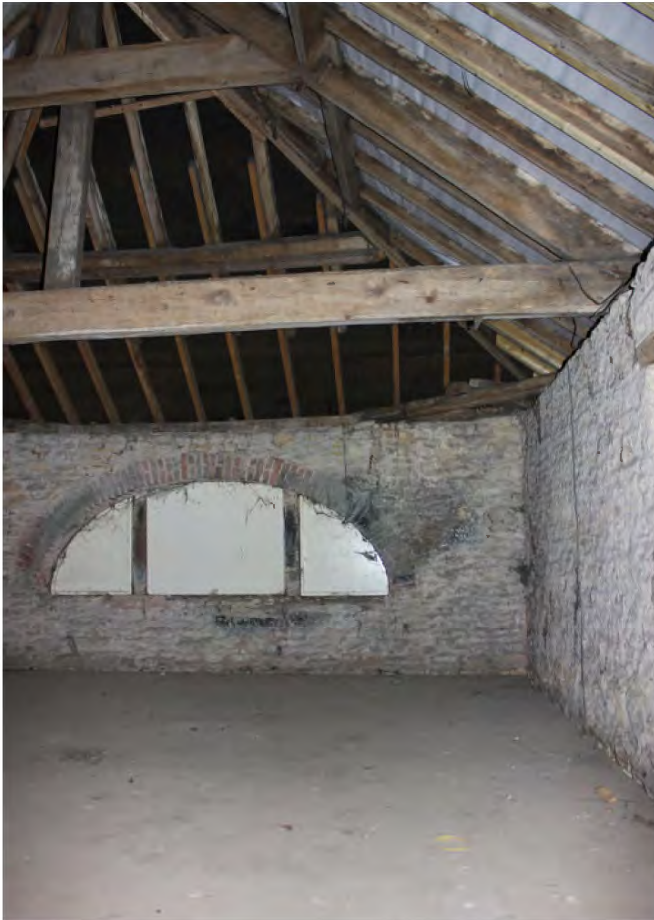
Hay loft or feed store with blocked Diocletian window with brick arch and stone mullions

The first floor is accessed from a timber staircase between the stables within the north wing. This leads directly into a white-washed room – the stair enclosure has been removed and replaced with temporary railings. The floor is modern and open to the rafters. The Diocletian window in the gable end is blocked with no evidence of a window frame or glazing, whilst another 'window' is in fact a pitching door. There is no evidence that this space was plastered or ceiled (plaster only exists to the former stair enclosure) leading to the conclusion that this space was a hay loft or feed store.

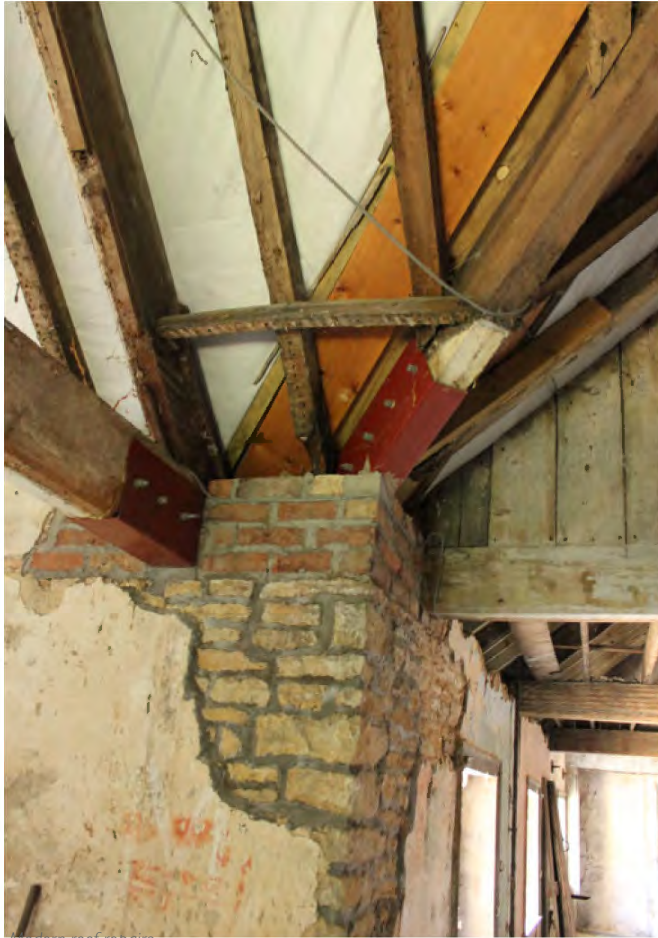
Modern roof repairs

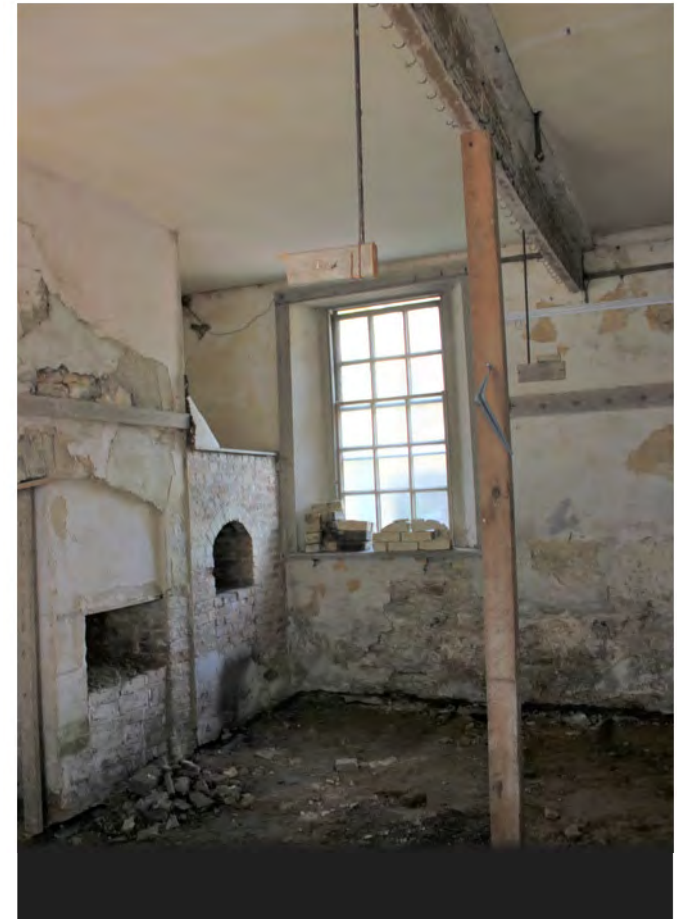
Ovens of a possible bakehouse/game larder

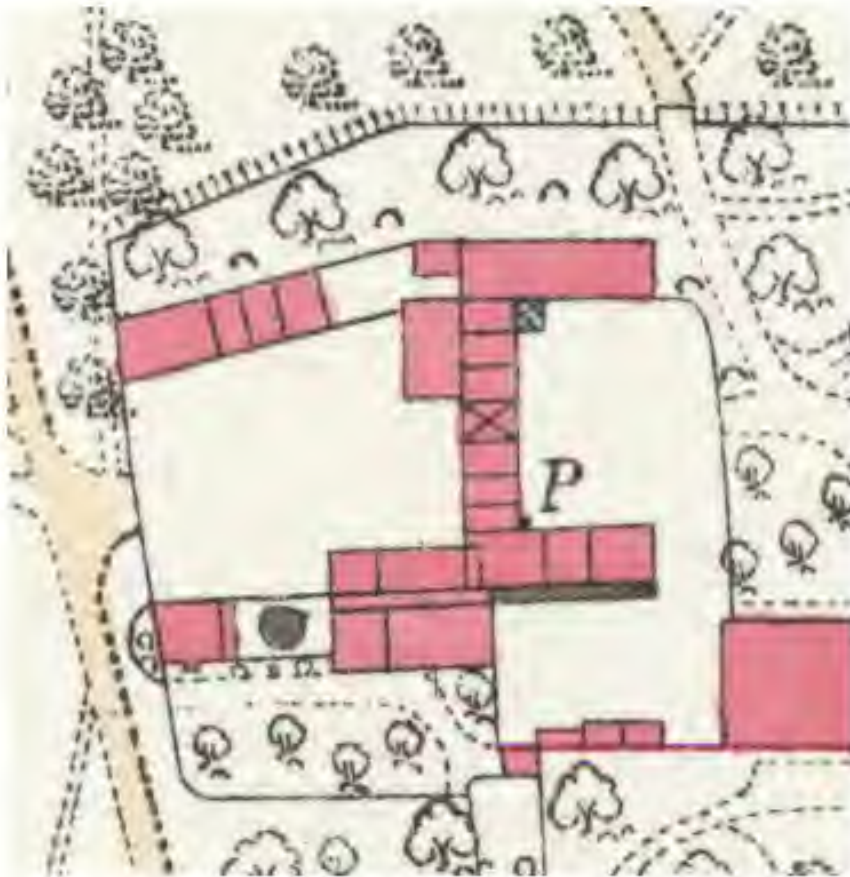
1890 (surveyed 1888) Ordnance Survey 25 inch of Hotham Hall.

The 1888 survey published in 1890 indicates the coach house and yards appear much as they do today. Perhaps in association with the 1872 works, the Stable Block received its southern range of buildings into the outer courtyard. The smithy's yard now contains a building appended to the rear of the north range.
